Hindringham 2008

Insurance Repair Circa £36,000 competitive tender

Under-pin house beside the stream then demolish and re install retaining wall damaged by flash flooding

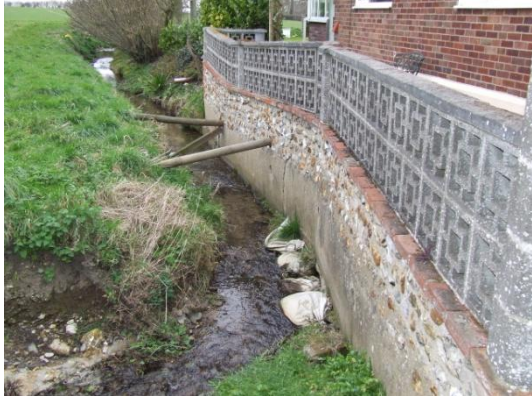
Flash flooding rose over the retaining wall and patio area causing the retaining wall to fail

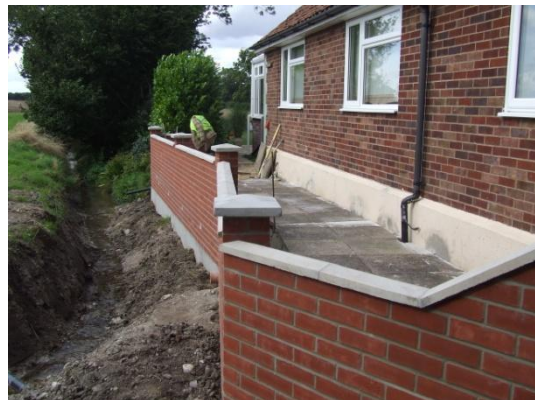
Stream back flowing down the original line
