Ludham Boathouse Piled Solution June 2011

G T Rochester Plant Ltd. was contacted by a structural engineer enquiring how to install bearing piles to a failing structure with poor access low head room over water. Working with our client G T Rochester Plant Ltd's solution was to install bracing and support to the building remove the cladding and using pullieblocks drop hammer and a piling winch install bearing piles to a known set

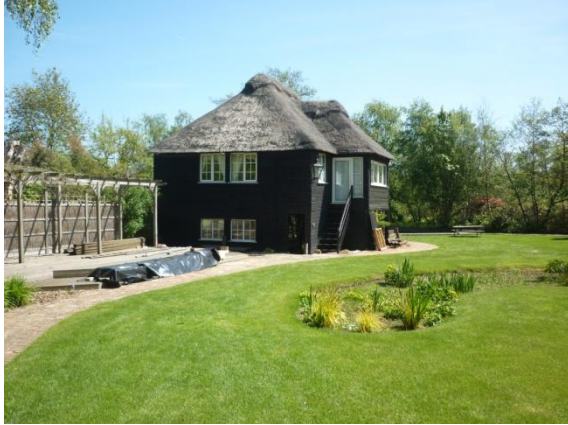
Above a thatched three bed roomed timber framed holiday cottage with a boat dock underneath

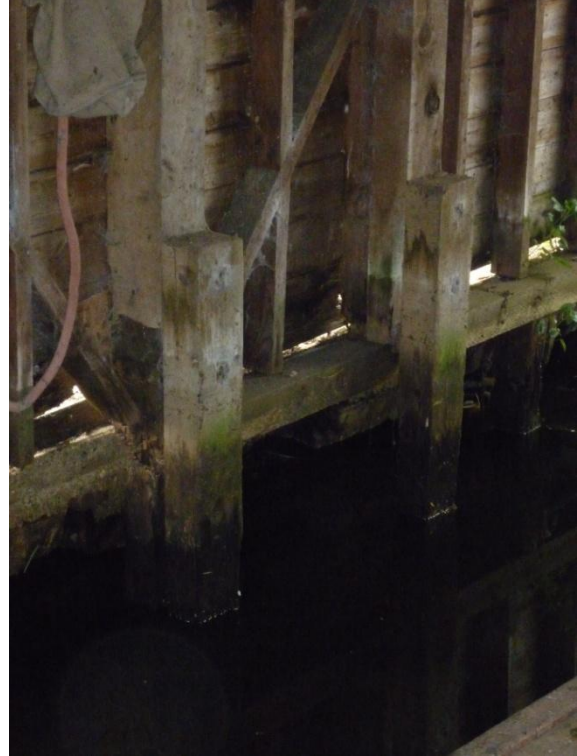
Right the original hard wood bearing piles had failed and been replaced by soft wood 'stilts' the replacement soft wood timbers were also in a bad state of decay

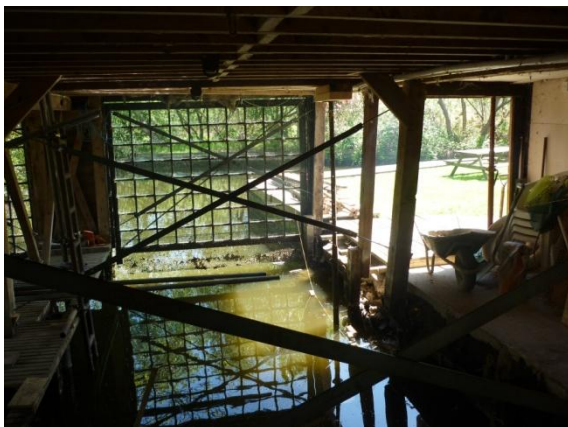
Installation of diagonal cross bracing

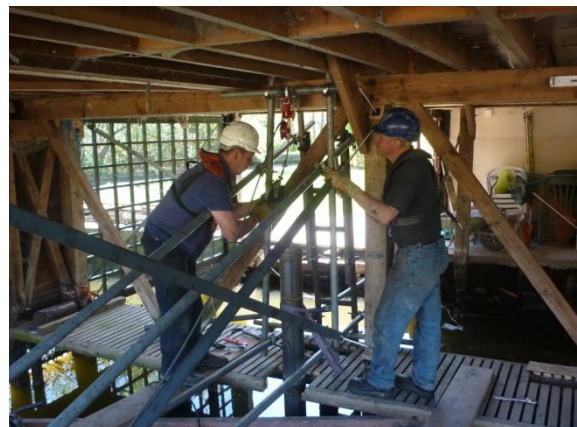
Installing a bottom driven pile with 150kg hammer (the man on the right is 5'9" tall)

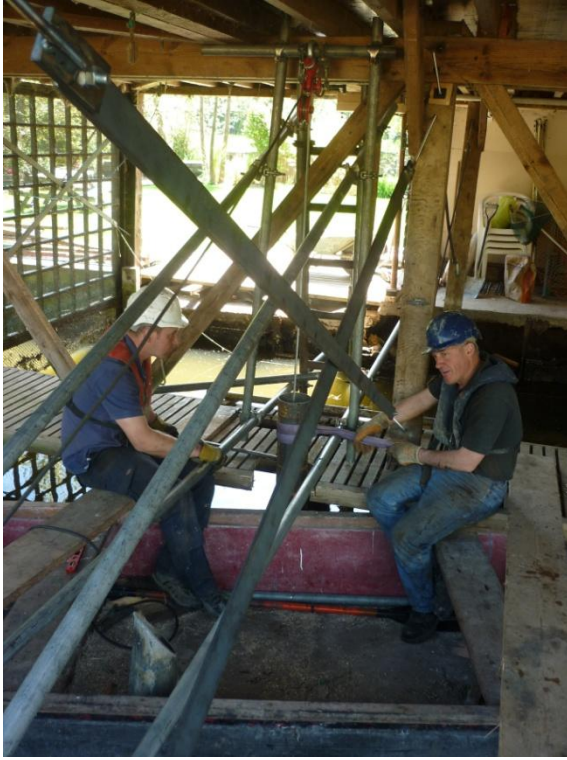
Using pulley blocks and bracing GTRP were able to install the bearing piles to a calculated set

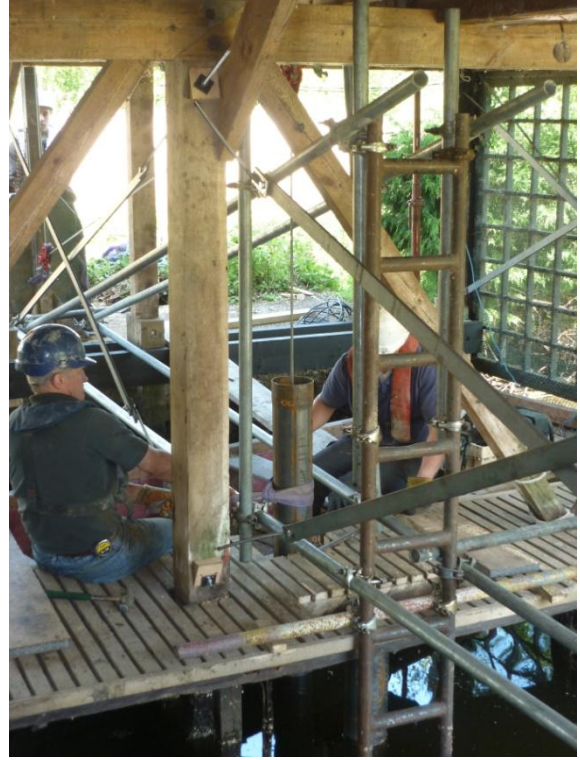
Using pulley blocks and bracing GTRP were able to install the bearing piles to a calculated set

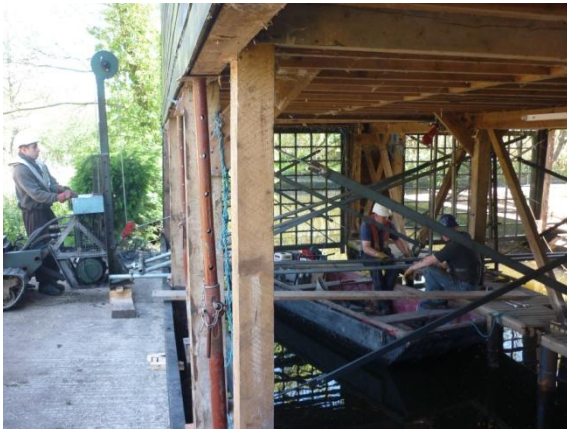
The mini piling rig standing outside of the building with the drop hammer wire running through pulley blocks
