Dry Dock Bearing Piles October 2009

Main contractor

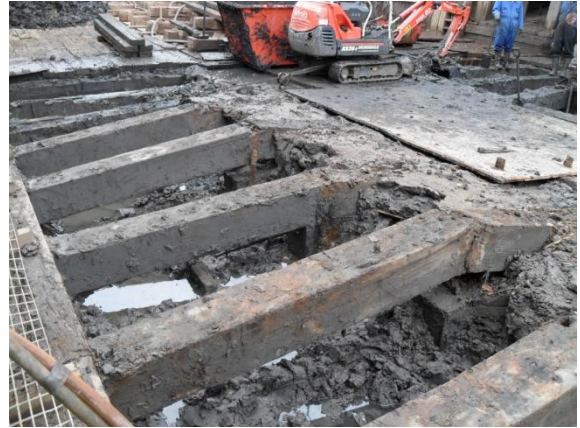
Due to the increase in size of ships being built the floor to this dry dock started to fail, under the dead weight transmitted through the keels of the vessels, The existing horizontal 12"x12" greenheart bearing beams had snapped & buckled to form a 'W' shape. G T Rochester plant Ltd installed 12no 13m x 325mm bottom driven bearing piles tremied with concrete along the keel line. The client removed the existing timberwork then after the piles were installed they installed a solid bearing beam and reinstated the hardwood timber deck to the bottom of the dry dock.

Snapped 12"x12" horizontal bearing beams

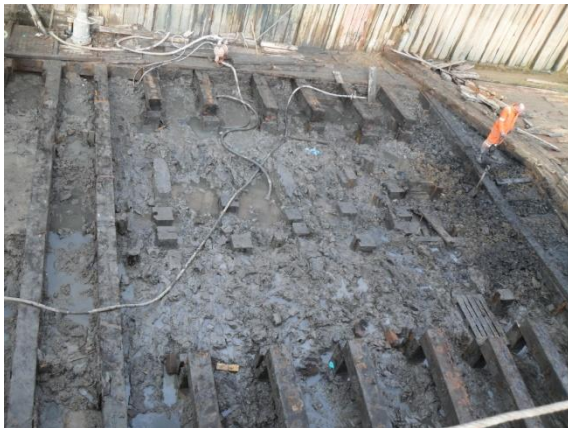
Area ready to install new bearing piles

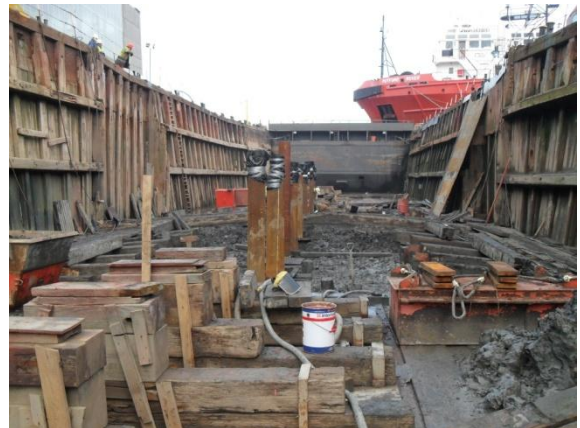
Installed bearing piles

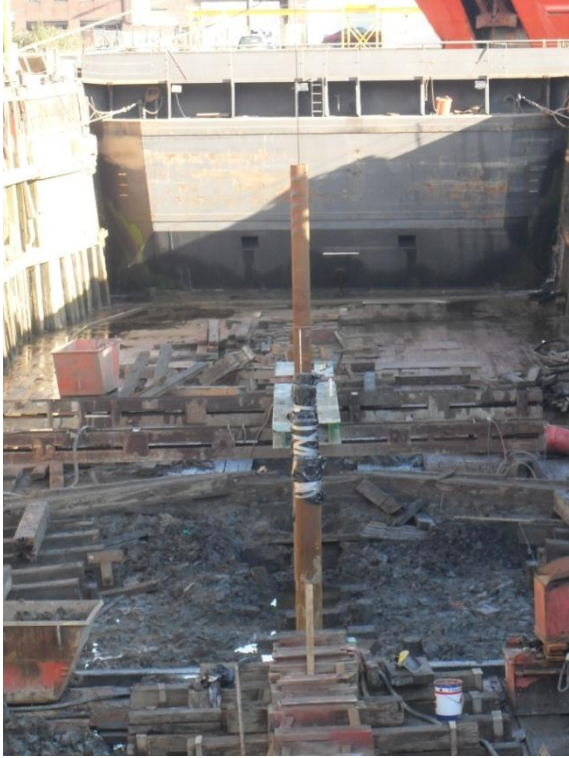
Installed bearing piles

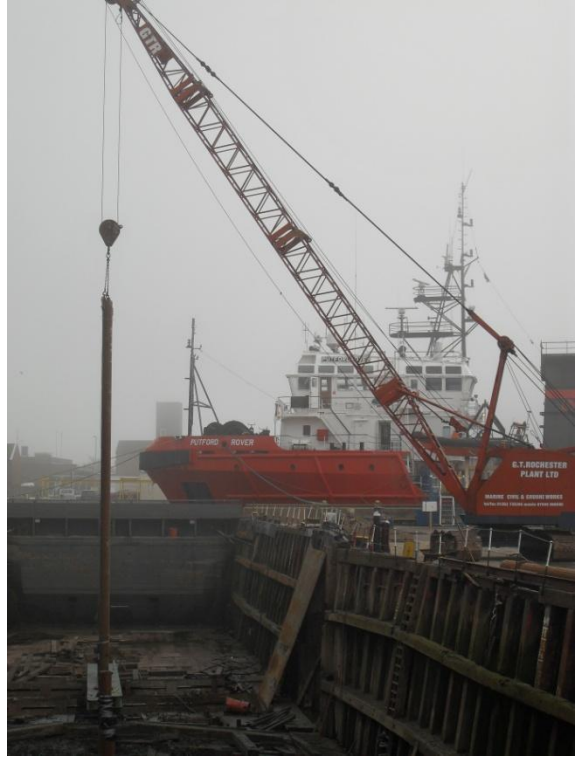
Installing pile into pile gates

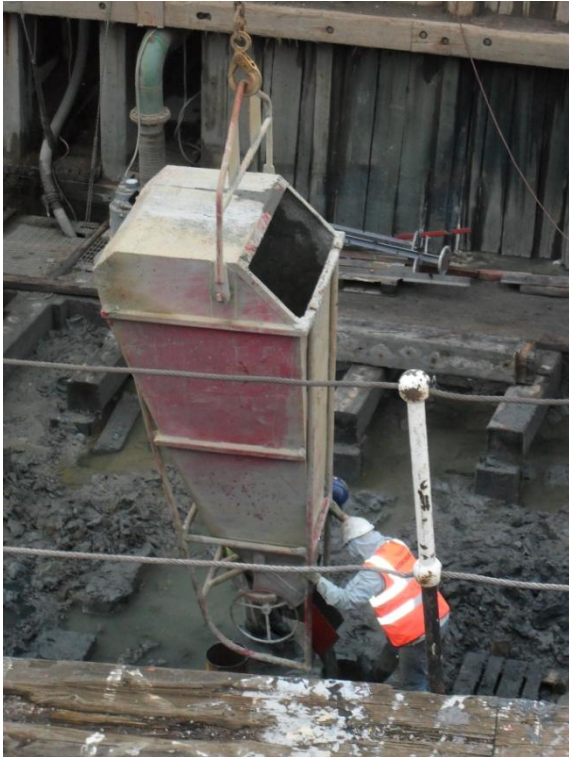
Treming concrete using our 2m³ skip

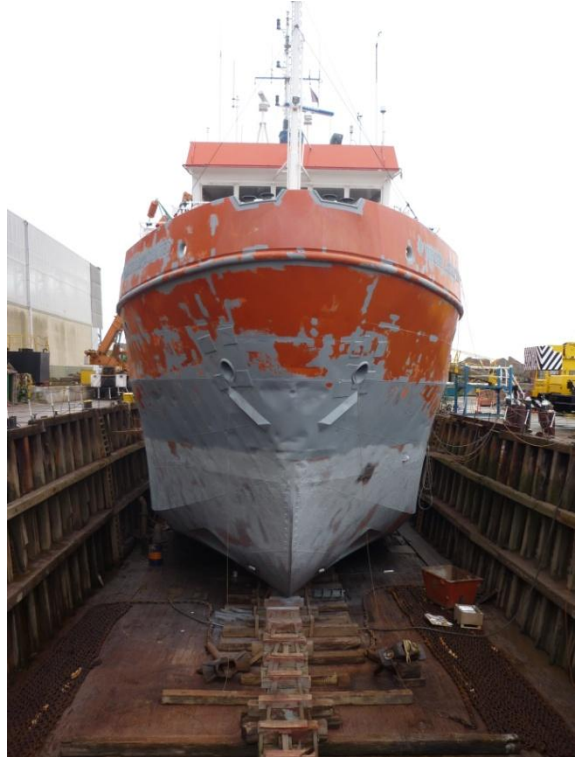
Finished and in use a 1300 ton vessel is the 1st vessel in dry dock after repair
